F-4-93 Daniel Shoemaker Farmstead Middletown Frederick County

Maryland Historical Trust
State Historic Sites Inventory Form

Survey No. F-4-93

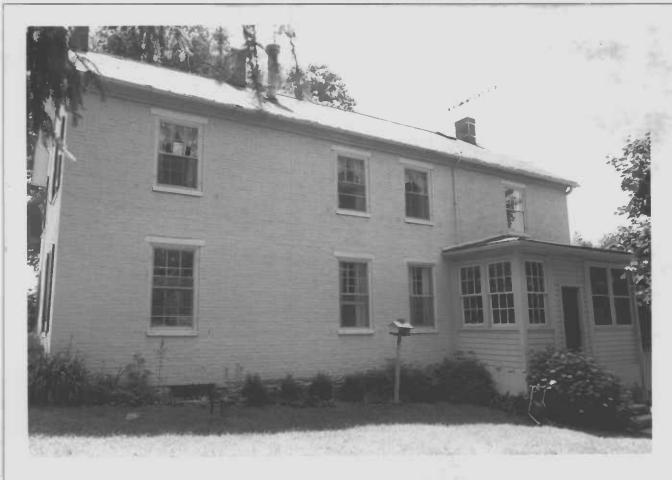
F 9-93 Frederick County Photo: Jonet Cours June 1992 Neg. loc.: Md. SHPO. Crownsville Mist West elevation

The dwelling is generally rectangular in shape and faces east with the main section at the north end of the rectangle and the wing on the south end. The main section has three bays on the east with a center entrance. A frame entry porch with a brick base is a recent replacement. The doorway has a four-panel door under a three-light transom and a paneled soffit. The brick exterior walls are laid in 6:1 American bond painted beige over brick red. A Frederick County Landmarks Foundation plaque, No. 270, is attached to the wall near the door. The cornice is corbeled and the gable roof, originally shingled, is now standing seam metal. The windows are 6/6 with plain lintels and sills flanked by louvred shutters. The wing has four bays on the east with an open two-story porch. Two entries containing four-panel doors alternate with 6/6 windows. The porch posts are chamfered and the railing is The south elevation of the house has no openings except a vertical board plain. door to the exposed stone basement and two 2/2 attic windows with louvred shutters. The west elevation has four irregular bays and a modern one-story frame porch projection on the rear of the wing. The projection has german siding. The north elevation has 5:1 bond and two bays of 6/6 windows, with attic windows as on the south elevation. The interior was inaccessible for this survey.

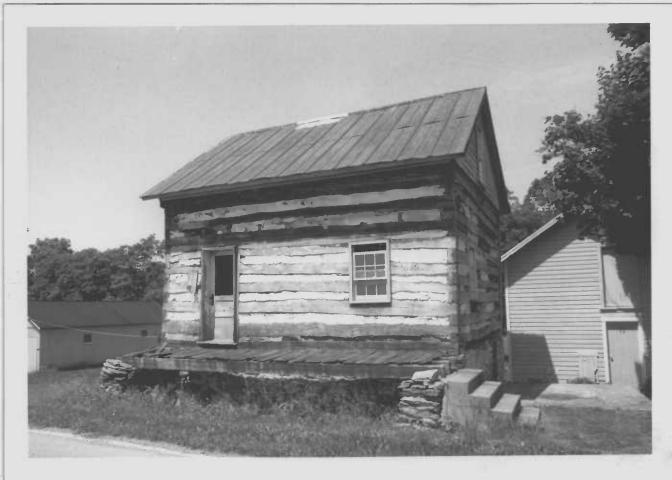
Donel Shoemaket Farmstead Frederick County Photo: Janet Cours June 1992 Neg. loc.: Md. SHPO, Orownsulle Md Log house east elevation 4/7

Log house: The one-story log structure is located southeast of the main dwelling at the edge of Mt. Tabor Road. It has an exposed stone foundation on the west and An exterior stone chimney base is located on the south elevation. The exposed log structure reveals wood nogging and interior lath. The north and south gables and the west elevation are covered with german siding. The east elevation has a single glazed panel door and a 6/6 window. Other window openings have missing The roof is standing seam metal, with a patched section indicating the location of an originally center chimney. At the northeast corner, a painted sign reading "+J. Shank+" is visible. Jacob Shank owned the farmstead from 1872 to 1905 and his descendants held the property until the mid-1970's. The current owner, Mrs. Dorr, stated that a late 1700's date was found in the interior chinking of the Its interior was not accessible for recording; however, the date of the building. building could be as early as the last quarter of the 18th century

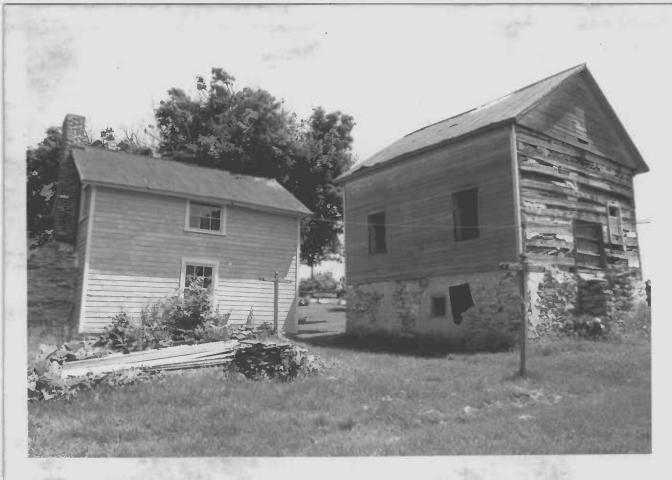
5-4-93 Cone Choemoker Formstead Frederick County Photo: Janet Days Neg. loc. Ald. SHro, Crownswille, Md Summer Kitchen and log house, view from south

Summer kitchen: The frame summer kitchen was built about 1910, according to Mrs. Dorr. It is located near the log house south of the dwelling. It has a rectangular plan with two levels, the lower being the exposed stone basement. The upper section is covered with german siding. At the northeast corner are vertical tongue and groove doors on both levels. The windows are 6/6 except for a 3/3 window on the south elevation of the upper level. An exterior stone and brick chimney is located on the south elevation and the gable roof is covered with corrugated metal.

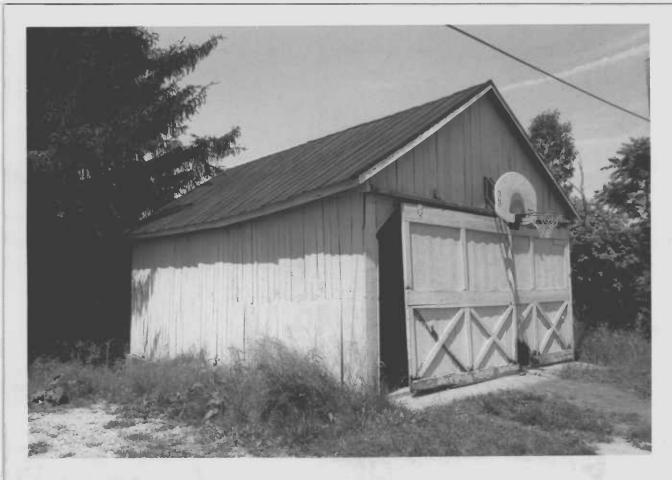
F-4-93 Doniel Choemaker Formstead Frederick County Photo: Jonet Davis June 1992 Nea. 100. Md. SHPO. Crownsville, Md Garage , Nouth Elevation

Garage: The frame garage was probably built about 1920. It stands northwest of the dwelling at the edge of Frostown Road facing the continuation of Mt. Tabor Road to the north of the complex. It appears to have been built over an earlier stone structure, perhaps an ice house, with an exposed south elevation. The upper structure has vertical board siding and sliding doors on the north elevation. The roof is standing seam metal.

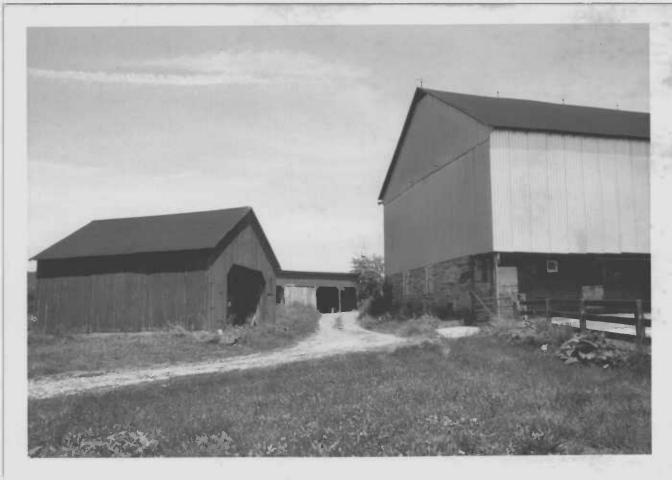
F-4-93 Duniel Shoemaker Formstead Frederick County Photo: Janet Dours JUNE 1992 Neg. loc. : Md. SHPO Crownsville Ald Wagen sheds and bonk born portial view From southeast

Bank barn and wagon shed/corn crib: The bank barn is located on the northeast side of Mt. Tabor Road. It was built about 1910, according to Mrs. Dorr, as a replacement for an earlier barn. It has metal siding probably concealing vertical boards. The lower level on the east elevation is enclosed with horizontal siding. The west elevation has sliding doors and the roof is covered with corrugated metal. The wagon shed/corn crib is located just southeast of the barn. Built about 1875-1900, it has vertical siding and a concrete foundation, which may replace an original stone foundation. The roof is standing seam metal. Both the barn and the wagon shed are located on Parcel 119, owned by Charles O. Myers and Betty A. Myers, 2717 Milt Summers Rd., Middletown, MD 21769.

Tractor shed: The frame tractor shed is located on the west side of Mt. Tabor Road directly west of the barn barn. It has five open bays on the east elevation, with vertical siding on the other elevations and a standing seam metal roof. It was probably built as a wagon shed in the period 1875-1900. The shed is located on Parcel 85, owned by Edgar E. and Gladys I. Poffenberger, 9109 Frostown Rd., Middletown, MD 21769.
